Vermont State Hospital
Brooks Building
Waterbury, Vermont

Psychiatric Facility Safety and Security Review

Based on an Inspection that took place on February 21, 2006

Vermont State Hospital (VSH)
Brooks Building
Psychiatric Units
Safety and Security Inspection

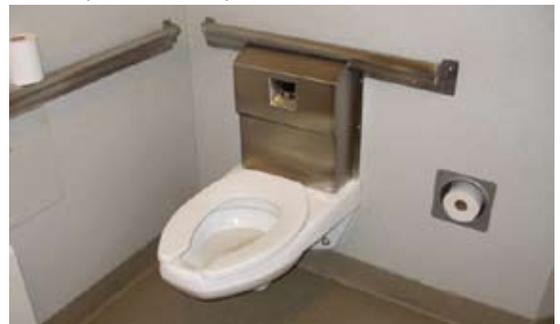
However, relative to safety and security, the Brooks Building provides patients with a remarkably safe, albeit unpleasant physical environment. We noted, for instance, the high level of safety and security that are exemplified by the care the VSH has taken to address typical problem areas such as plumbing fixture protections. (See Below)

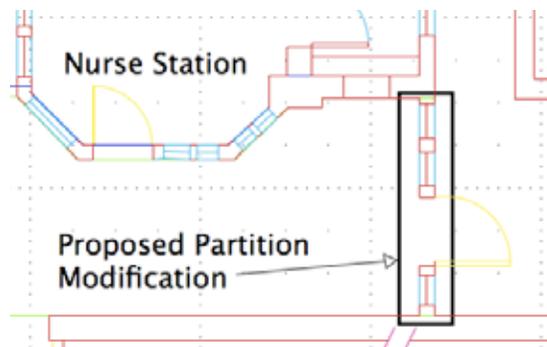
Nurse's Station: (the bubble) is well located to provide visual control of the unit including the point of access, and patient bedroom doors. The benefit of this location is compromised by the partition that separates the porch side bedrooms from the rest of the unit.

Recommendation (PM): Delete the solid partition and door, or replace the solid partition with a hollow metal and glass partition similar to the previous recommendation.

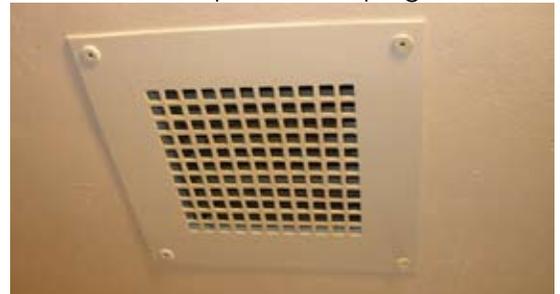
Ceiling Diffuser: A ceiling diffuser (see below) was noted in the telephone booth opposite the nurse's station. This type of ceiling diffuser, with square openings in excess of 1/2" is a possible looping hazard.

Recommendation (HSW): All such ceiling diffusers should be replaced with risk resistant security grills and registers with the following specification: The face plate will be of 12 GA steel with 5/32" or 7/32" perforated holes (for risk resistance) with a 1/2" "hug tight" lip. A secondary 14 GA face plate mated and spot welded to the front face giving an overall 3/16" seamless face plate appearance. An optional stainless steel (16-16-mesh) screen may be spot welded to the back of the face plate for further risk and contraband reduction. The face plate will be attached by pinned flat head torx security screws to a suitable edge.:

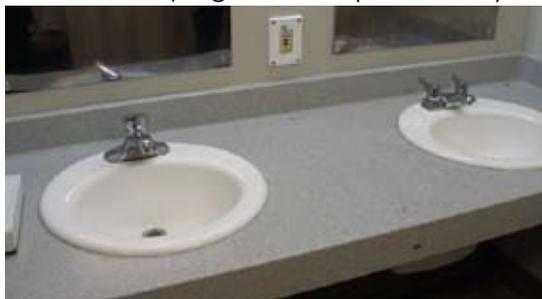
Men's Bathroom has several areas of concern that should be remedied. The sinks are mounted on a plastic laminate counter. The faucets are of a type that could cause a "looping" hazard. (See Below)

Recommendation (HSW): We recommend these, and all similar faucets in the facility be replaced with a "loop-proof" automatic controlled faucets similar to those depicted below.

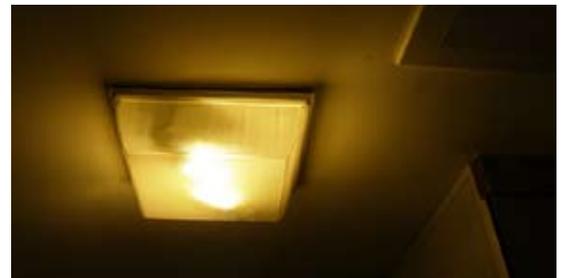
Ceiling Fixture (HSW): It does not appear that the ceiling fixture in the men's bathroom area above the sinks is mounted properly which could cause a potential hazard.

Recommendation: The light fixture should be mounted properly to, prevent removal.

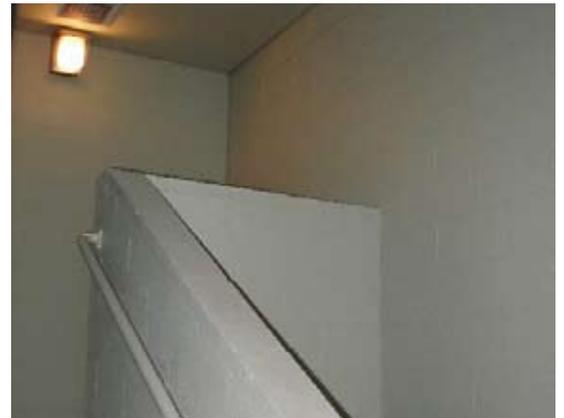
Stairwell: There is an open stairwell at the South end of unit.

Recommendation (HSW): This stairwell should be enclosed with a metal partition with a fine mesh that would extend from the top of the solid handrail to at least 7' above the stair nosing to eliminate the possibility of someone jumping.

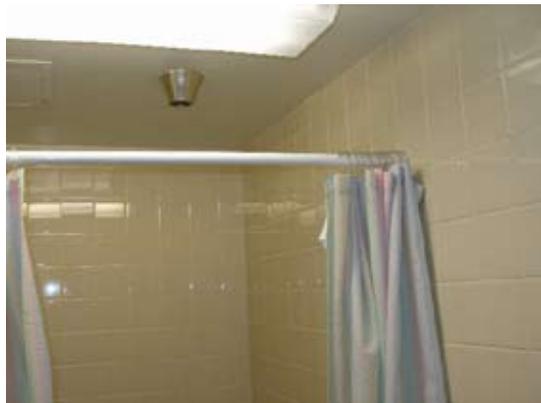
Shower Rods: The photograph that follows shows a typical installation in patient bathroom shower areas. (Note the proper, institutional sprinkler head that demonstrates a general high level of care for safety that is evident throughout the facility).

However, the shower curtain is supported by a "breakaway" shower rod. Although this installation is very common in current mental health facilities, we feel the ease of removal of this building element could give a patient access to a "weapon" that could cause injury to other patients or staff.

Recommendation (PM): We believe a more effective shower curtain suspension system involves a flush mounted curtain track and velcro clasps as depicted below. Please note the loop-proof shower head and the flush mounted light fixture.

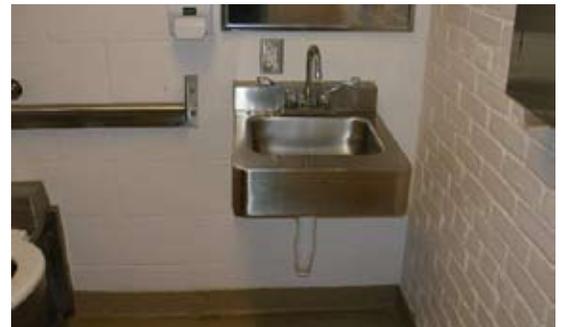
Activity Area Bathroom: The drain under the sink has not been boxed in nor is the faucet on the sink a loop-proof design. The toilet paper dispenser has a fixed spindle that could become a looping hazard.

Recommendation (HSW): Pipes under the sink should be enclosed and toilet paper holder should be fully recessed to avoid the potential for harm to patients. (This type of holder is used in other bathrooms in the facility).
